BERRY POND DAM

NH 00105

PHASE I INSPECTION REPORT
NATIONAL DAM INSPECTION PROGRAM

AUGUST 1978

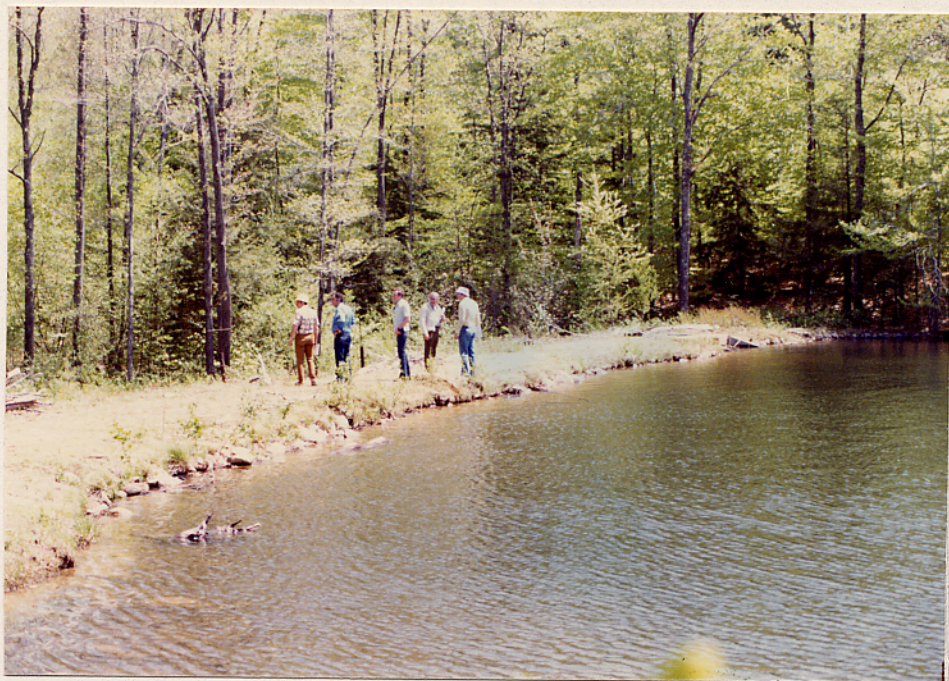
Overview from left abutment

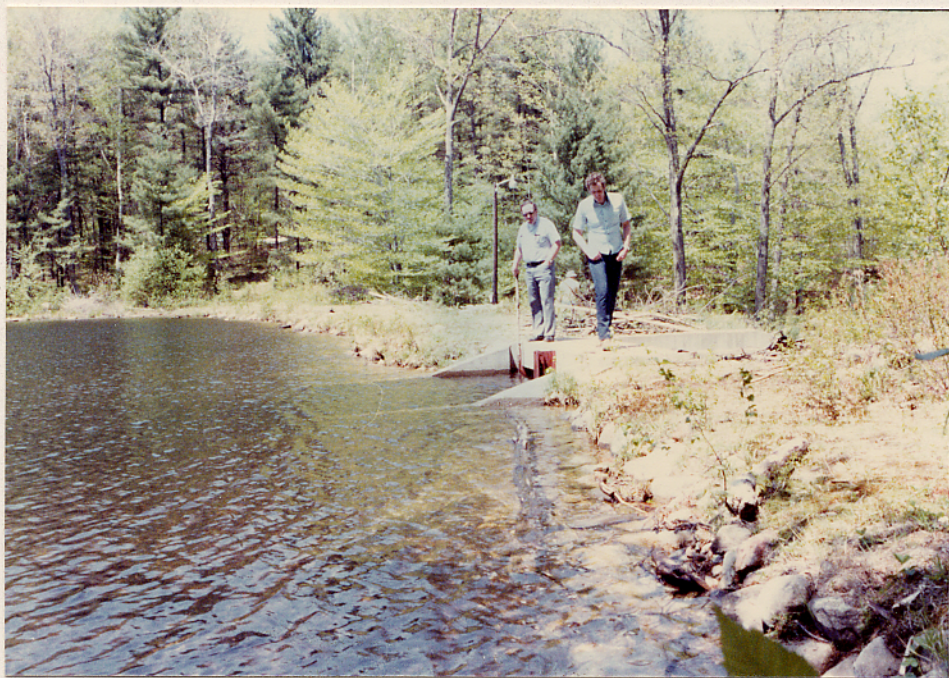
Overview from right abutment

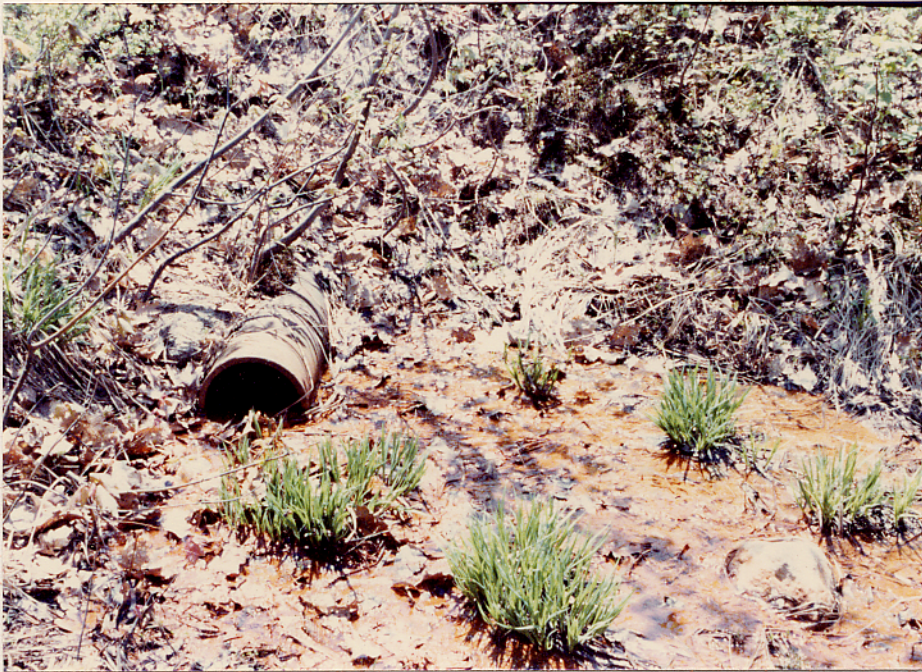
Two seepage areas were noted on the downstream slope of the earth dam. One seepage point is located 89 feet to the left of the concrete outlet box along the centerline of the earth embankment and approximately 25 feet downstream of and roughly 9 feet lower in elevation than the crest of the earth dam. Seepage was estimated at less than 0.05 gpm. A second seepage point was noted on the right abutment where the 10-inch outlet pipe exits on the slope. The seepage on the outside of the pipe is rust-colored and is estimated as less than 0.1 gallons per minute. It is understood that this outlet pipe has been plugged with concrete at its upstream end.

1. Seepage alongside abandoned outlet pipe looking downstream

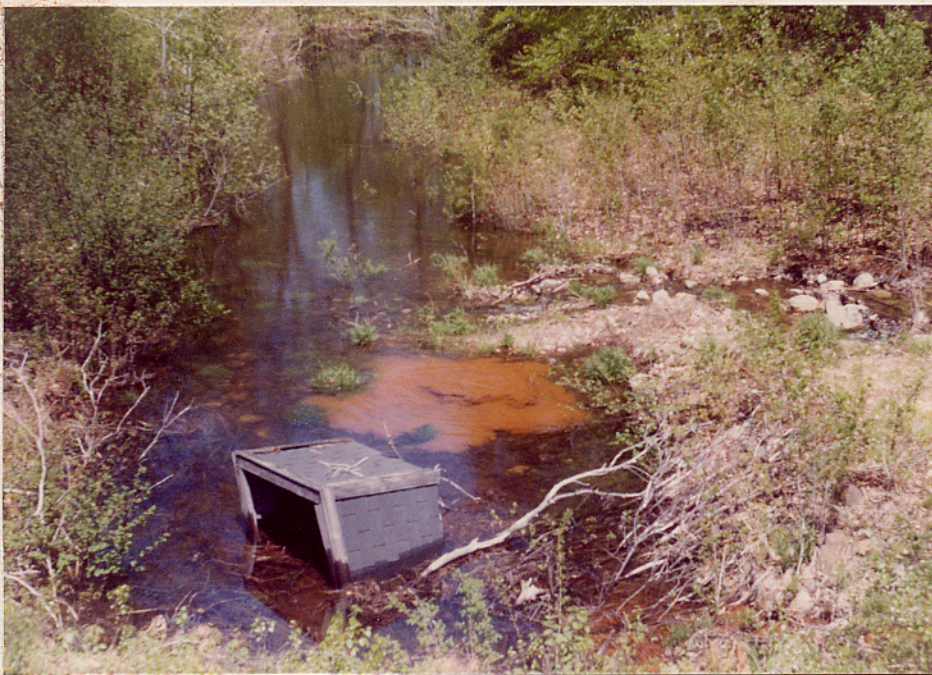
2. Outlet channel showing discharge of silt-laden water upon opening of outlet gate

Investigation should be made of improved draw-down facilities to supplement the 8 inch water supply line which is inadequate for this purpose.
